Appendix C. Non-Structural Data and Assessment Sheets

STRUCTURE DATA / ASSESSMENT SHEET

ID #	COUNTY	STREET ADDRESS	OCCUPANCY
OH-01	Allegheny	1153 Old Freeport Road	Commercial

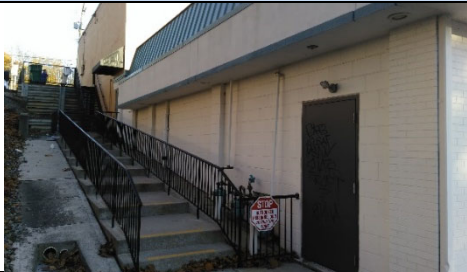
Side View, South

General: The structure was observed from the exterior only. The structure was occupied and in good condition. The grade behind the structure slopes uphill towards the west. The structure is situated in a suburban site and is free standing.

Construction: The structure has two stories. Foundation is concrete slab. Construction is concrete block with brick veneer. The structure has four first-floor pedestrian doorways.

Flood Risk: This structure intersects the 1% annual chance exceedance (ACE) floodplains for Squaw Run and the Allegheny River. The first-floor elevation is approximately 4'-7" and 3'-3" below the 1% ACE flood elevation along Squaw Run and the Allegheny River, respectively. The lowest grade is approximately 5'-4" and 4'-0" beneath the 1% ACE flood elevation along Squaw Run and the Allegheny River, respectively.

Proposed Mitigation Measure	Estimated Cost
<i>Actions to reduce flood risk up to the 1% ACE flood elevation:</i>	
1. Acquisition and relocation due to depth of inundation and proximity to stream OR	1. No Data
2. Evacuate first floor. Elevate utilities to second floor or addition. Install flood louvers in exterior walls.	2. No Data
<i>Actions to reduce flood risk associated with flood elevations below the 1% ACE flood:</i>	
3. Dry flood-proofing—Repair, maintain, and modify exterior walls/windows as needed. Install flood-proof doors, backflow preventer, and sump pump with emergency power. Dry flood-proof to a maximum height of 3'-0". <i>Note: Will not lower flood insurance rates or reduce risk up to the 1% ACE event.</i>	3. \$260,000

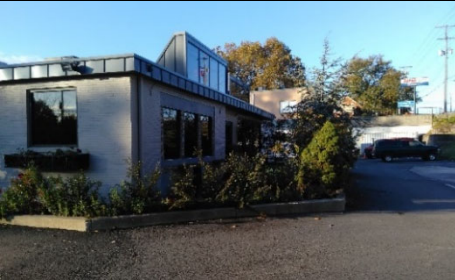
Side View, East

General: The structure was observed from the exterior only. It was occupied and in good condition. The grade around the structure is level. The structure is situated on a suburban site and free standing. The structure has a large paved parking lot in the front of the structure.

Construction: The structure is a one-story building. Foundation is slab on-grade. Exterior wall construction is a combination of brick and concrete block. The structure has 10 pedestrian doorways.

Proposed Mitigation Measure	Estimated Cost
<p><i>Actions to reduce flood risk up to the 1% ACE flood elevation:</i></p> <ol style="list-style-type: none"> Acquisition and relocation due to depth of inundation and proximity to stream. 	<ol style="list-style-type: none"> No Data
<p><i>Actions to reduce flood risk associated with flood elevations below the 1% ACE flood:</i></p> <ol style="list-style-type: none"> Dry flood-proofing—Repair, maintain, and modify exterior walls/windows as needed. Install flood-proof doors, backflow preventer, and sump pump with emergency power. Construct water-proof barrier around electrical panels. Dry flood-proof to a maximum height of 3’-0”. <i>Note: Flood-proofing will not lower flood insurance rates or reduce risk up to the 1% ACE event.</i> 	<ol style="list-style-type: none"> \$411,000

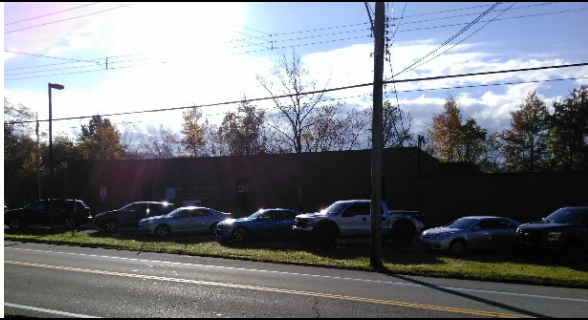
Front View, Northeast

General: The structure was observed from the exterior only. It was occupied and in good condition. The grade around the structure is flat. The structure is situated on a suburban site and free standing. The structure has four integral garages at the rear of the structure.

Construction: The structure is a one-story building. Foundation is concrete slab. The structure has four pedestrian doorways.

Proposed Mitigation Measure	Estimated Cost
<p><i>Actions to reduce flood risk up to the 1% ACE flood elevation:</i></p> <p>1. Dry flood-proof to 2'-0" above the Squaw Run 1% ACE flood elevation. Repair, maintain, and modify exterior walls/windows as needed. Install flood-proof doors and stop logs for garage doors. Install backflow preventer and sump pump with emergency power.</p>	<p>1. \$363,000</p>

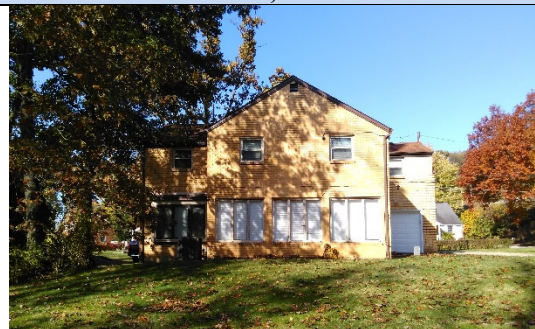
Side View, Southeast

Construction: The structure is a two-story building with a full basement, which has had standing water. A back-flow preventer has been installed. Foundation of the main structure is concrete block. Foundation of the garage is concrete slab. The structure is wood framed with brick veneer. The structure has 14 structural corners, two pedestrian doorways, and one chimney.
