Appendix C. Non-Structural Data and Assessment Sheets

STRUCTURE DATA / ASSESSMENT SHEET

ID #	COUNTY	STREET ADDRESS	OCCUPANCY
OH-01	Allegheny	1153 Old Freeport Road	Commercial

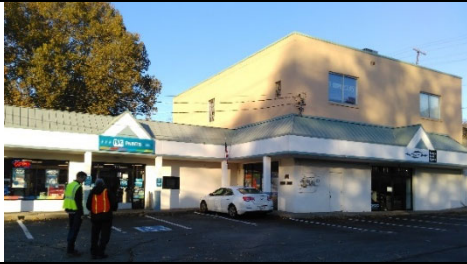
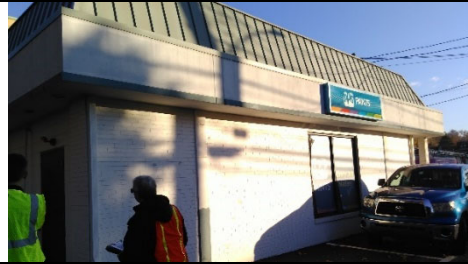
Font View, East

General: The structure was observed from the exterior only. The structure was occupied and in good condition. The grade behind the structure slopes uphill towards the west. The structure is situated in a suburban site and is free standing.

Construction: The structure has two stories. Foundation is concrete slab. Construction is concrete block with brick veneer. The structure has four first-floor pedestrian doorways.

Flood Risk: This structure intersects the 1% annual chance exceedance (ACE) floodplains for Squaw Run and the Allegheny River. The first-floor elevation is approximately 4'-7" and 3'-3" below the 1% ACE flood elevation along Squaw Run and the Allegheny River, respectively. The lowest grade is approximately 5'-4" and 4'-0" beneath the 1% ACE flood elevation along Squaw Run and the Allegheny River, respectively.

Proposed Mitigation Measure	Estimated Cost
<i>Actions to reduce flood risk up to the 1% ACE flood elevation:</i>	
1. Acquisition and relocation due to depth of inundation and proximity to stream OR	1. No Data
2. Evacuate first floor. Elevate utilities to second floor or addition. Install flood louvers in exterior walls.	2. No Data
<i>Actions to reduce flood risk associated with flood elevations below the 1% ACE flood:</i>	
3. Dry flood-proofing—Repair, maintain, and modify exterior walls/windows as needed. Install flood-proof doors, backflow preventer, and sump pump with emergency power. Dry flood-proof to a maximum height of 3'-0". <i>Note: Will not lower flood insurance rates or reduce risk up to the 1% ACE event.</i>	3. \$260,000

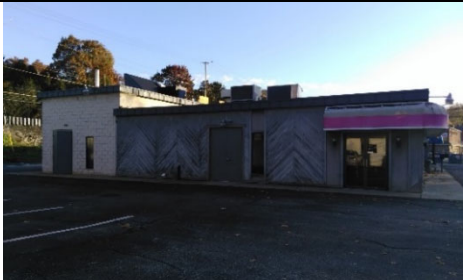
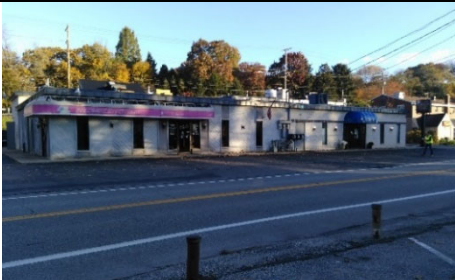
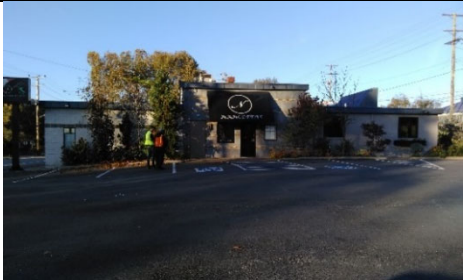
Side View, West

General: The structure was observed from the exterior only. It was occupied and in good condition. The grade around the structure is level. The structure is situated on a suburban site and free standing. The structure has a large paved parking lot in the front of the structure.

Construction: The structure is a one-story building. Foundation is slab on-grade. Exterior wall construction is a combination of brick and concrete block. The structure has 10 pedestrian doorways.

Proposed Mitigation Measure	Estimated Cost
<p><i>Actions to reduce flood risk up to the 1% ACE flood elevation:</i></p> <ol style="list-style-type: none"> Acquisition and relocation due to depth of inundation and proximity to stream. 	<ol style="list-style-type: none"> No Data
<p><i>Actions to reduce flood risk associated with flood elevations below the 1% ACE flood:</i></p> <ol style="list-style-type: none"> Dry flood-proofing—Repair, maintain, and modify exterior walls/windows as needed. Install flood-proof doors, backflow preventer, and sump pump with emergency power. Construct water-proof barrier around electrical panels. Dry flood-proof to a maximum height of 3’-0”. <i>Note: Flood-proofing will not lower flood insurance rates or reduce risk up to the 1% ACE event.</i> 	<ol style="list-style-type: none"> \$411,000

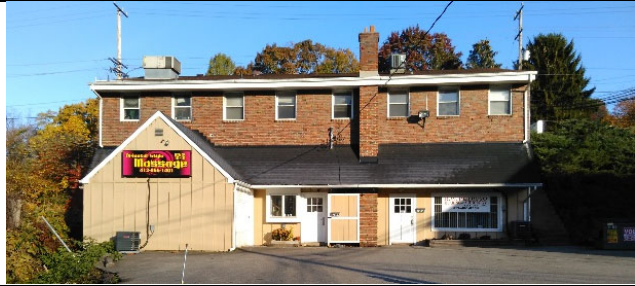
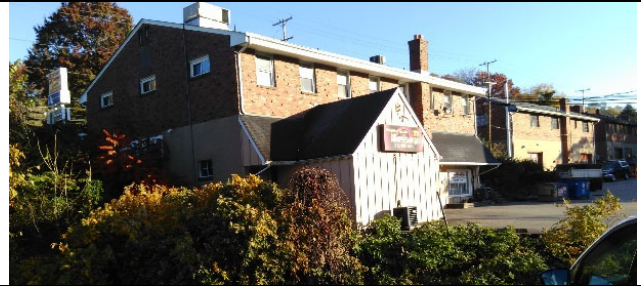
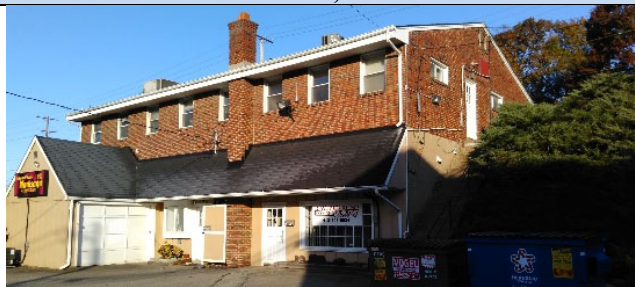
Rear View, South

General: The structure was observed from the exterior only. It was occupied and in good condition. The grade around the structure is sloping to the southwest. The structure is situated on a suburban site, free standing, with an attached garage.

Construction: The structure is a two-story building. Foundation is concrete slab/reinforced slab. Exterior wall construction is a combination of concrete block with brick and wood siding veneer. The structure has two first-floor pedestrian doorways. The structure has one chimney.

Proposed Mitigation Measure	Estimated Cost
<i>Actions to reduce flood risk up to the 1% ACE flood elevation:</i>	
1. Elevate first floor approximately 2'-6" by placing fill and pouring new concrete slab. Elevate ceiling. Dry flood-proof to a maximum height of 3'-0". Repair, maintain, and modify exterior walls/windows as needed. Install flood-proof doors, backflow preventer, and sump pump with emergency power. Construct a masonry wall around the exterior electrical panel. Elevate HVAC units to 2'-0" above both 1% ACE flood elevations. Remove or wet flood-proof attached garage by elevating all storage 2'-0" above both 1% ACE flood elevations.	1. \$318,000

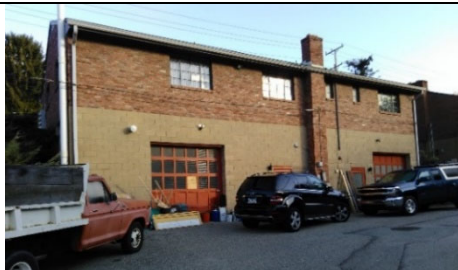
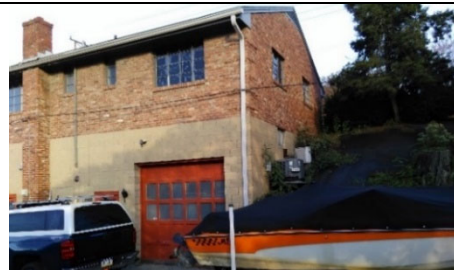
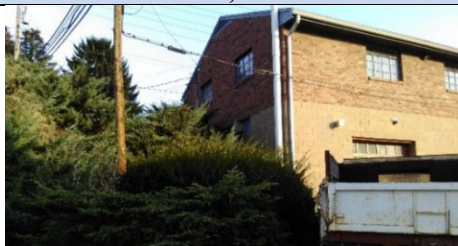
Rear View, Southwest

General: The structure was observed from the exterior only. It was occupied and in good condition. The grade around the structure is sloping uphill to the north. The structure is situated on a suburban site and free standing with two integral garages.

Construction: The structure is a two-story building. Foundation is concrete slab and reinforced slab. The structure construction is concrete block and wood framing with brick veneer. The structure has two pedestrian doorways on the first floor. The structure has one chimney.

Proposed Mitigation Measure	Estimated Cost
<i>Actions to reduce flood risk up to the 1% ACE flood elevation:</i>	
1. Wet flood-proofing—Elevate equipment and storage to 2'-0" above both 1% ACE flood elevations. Install backflow preventer in exterior walls.	1. \$21,000
OR	
2. Dry flood-proofing—Repair, maintain, and modify exterior walls as needed. Install flood-proof pedestrian doors and barriers for garage door. Install backflow preventer and sump pump with emergency power. Dry flood proof to 2'-0" above both 1% ACE flood elevations.	2. No Data

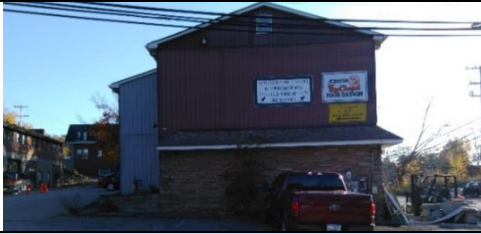
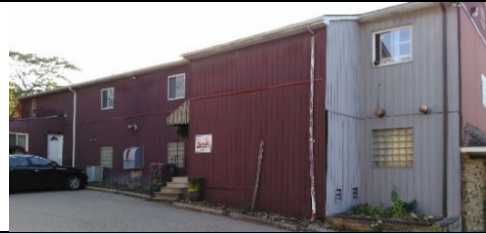
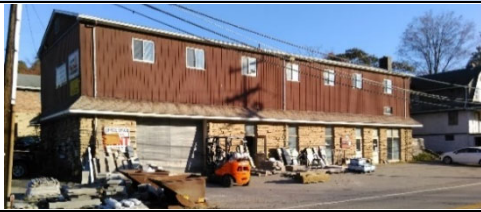
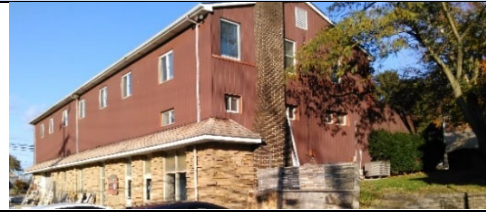
Side View, West

General: The structure was observed from the exterior only. It was occupied and in fair condition. The grade slopes upward behind the structure. The structure is situated on a suburban site, is free standing, with an integral garage.

Construction: The structure has two-stories. Foundation is concrete slab. External walls are a combination of stone, metal, and wood siding. The structure has five pedestrian doorways and one chimney.

Proposed Mitigation Measure	Estimated Cost
<i>Actions to reduce flood risk up to the 1% ACE flood elevation:</i>	
1. Construct elevated first floor in garage. Elevate floor approximately 3'-11" by placing fill and pouring new concrete slab. Dry flood-proof garage to a maximum height of 3'-0". Repair, maintain, and modify exterior walls/windows as needed. Install flood-proof doors and stop logs for garage door. Install backflow preventer and sump pump with emergency power. Wet flood-proof office/display area and install flood louvers in exterior walls. Ensure HVAC units are 2'-0" above both 1% ACE flood elevations.	1. \$179,000
OR

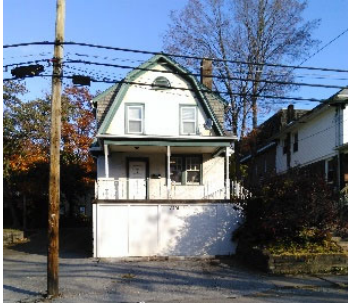
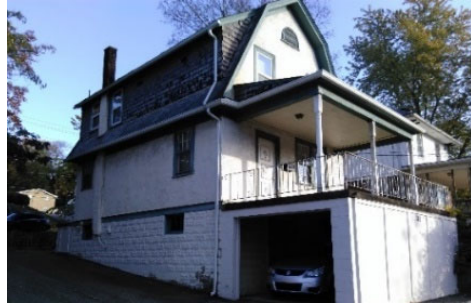
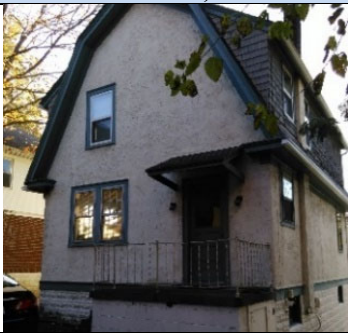
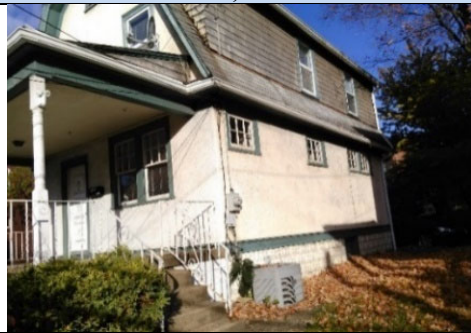
Front View, South

General: The structure was observed from the exterior only. It was occupied and in fair condition. The grade around the structure slopes upward toward the rear of the structure. The structure is situated on a suburban site, free standing, with an integral one-car garage. The structure has concrete front and rear porches.

Construction: The structure is a two-story building with a full, walk-out basement. Foundation of the main structure is concrete block. Foundation of the garage is concrete slab. The structure is wood framed with stucco finish. The structure has six structural corners, four pedestrian doorways, and two chimneys.

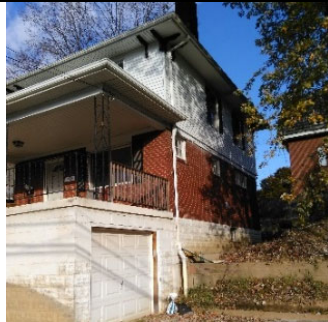
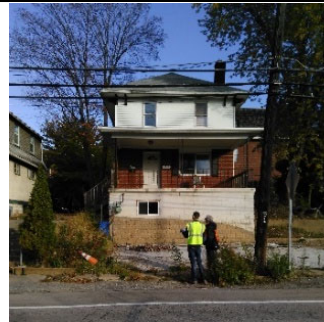
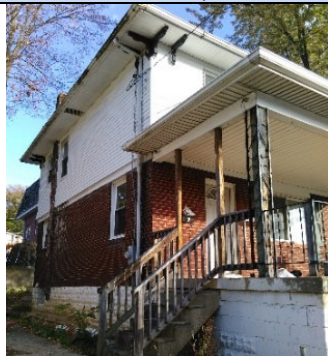
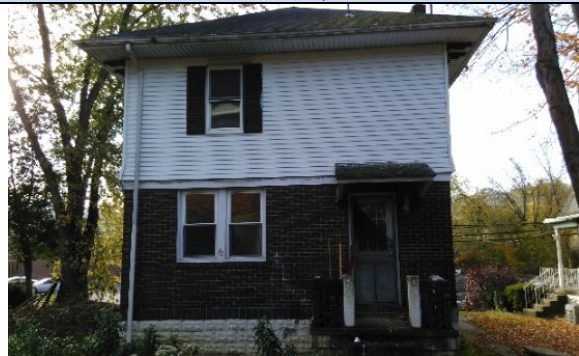
Front Side View, Southeast

General: The structure was observed from the exterior only. It was occupied and in fair condition. The grade slopes upward toward the rear of the structure. The structure is situated on a suburban site, free standing, with an integral one-car garage. The structure has concrete front and rear porches.

Proposed Mitigation Measure	Estimated Cost
<p><i>Actions to reduce flood risk up to the 1% ACE flood elevation:</i></p> <p>1. Relocate utilities to first floor or addition. Fill basement and install flood louvers in exterior walls. Wet flood-proof garage. Elevate storage to 2'-0" above both 1% ACE flood elevations.</p>	<p>1. \$106,000</p>

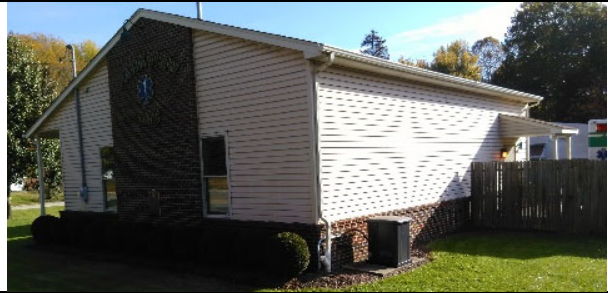
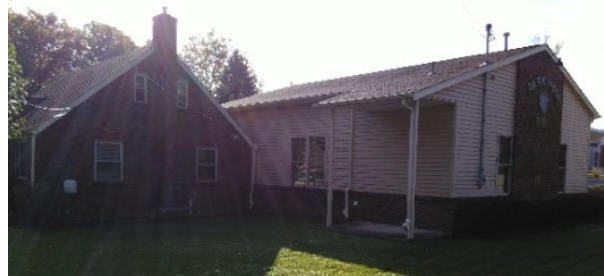
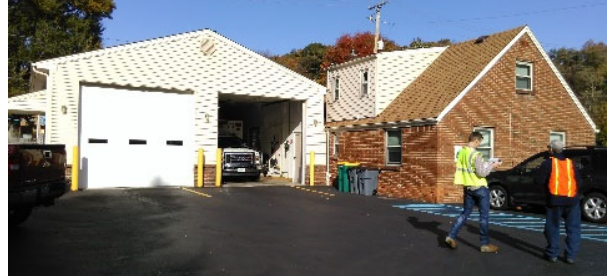
General: The structure was observed from the exterior only. It was occupied and in good condition. The grade around the structure is level. The structure is situated on a suburban site and free standing.

Construction: The structure is a two-story building that consists of the original structure and attached two-car garage in the rear, which houses emergency vehicles. The main structure has a full basement. The garage has a concrete slab foundation. The structure is wood framed with brick and vinyl siding veneer. There are eight structural corners, three pedestrian doorways, and one chimney.

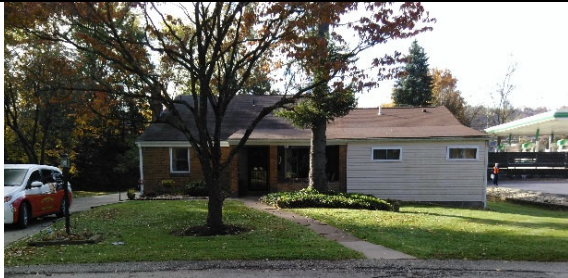
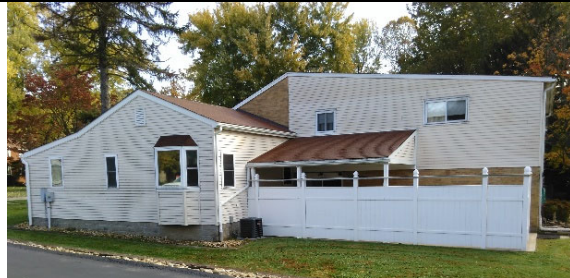
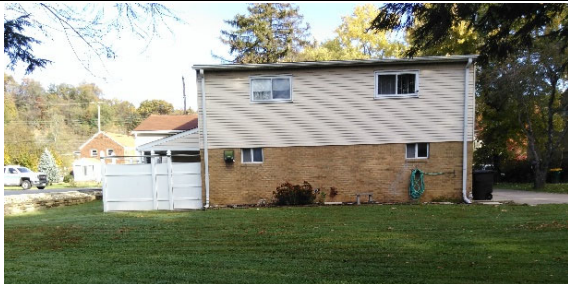
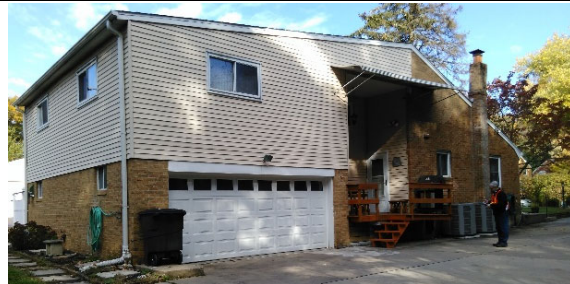
ID #	COUNTY	STREET ADDRESS	OCCUPANCY
OH-14	Allegheny	204 South Margery Dr.	Residential

General: The structure was observed from the exterior only. It was occupied and in good condition. The grade around the structure is level. The structure is situated on a suburban site and free standing. The structure has a concrete front porch and a wooden rear deck (~11'x14').

Construction: The structure is a two-story building. The original structure has a full basement with a concrete block foundation. A two-story addition (lower garage with second story living space) was added in the rear of the structure. The foundation of the rear addition is slab on grade. There is a one-story addition on the west side of the structure with a crawl space and concrete block foundation. The entire structure is wood framed with brick veneer and vinyl siding. The structure has an integral two-car garage. The structure has 13 structural corners, three pedestrian doorways, and one chimney.

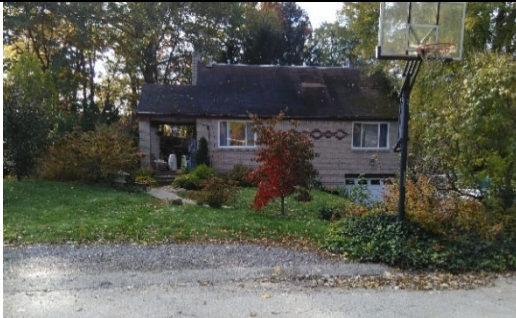
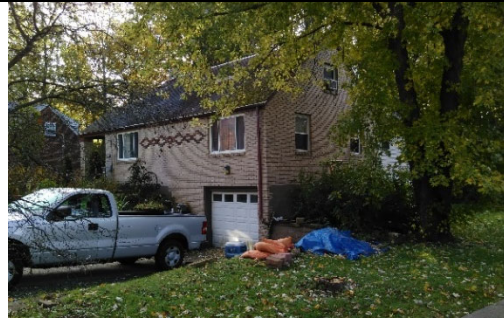
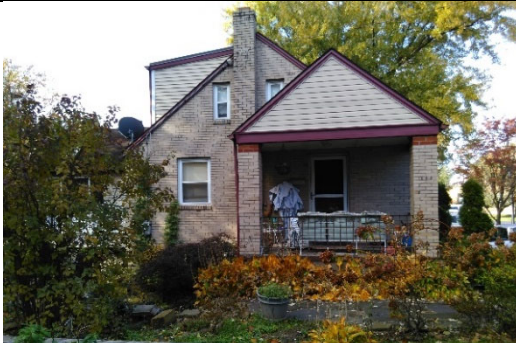
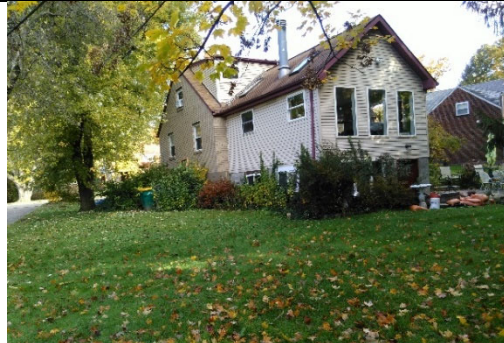
ID #	COUNTY	STREET ADDRESS	OCCUPANCY
OH-15	Allegheny	206 South Margery Dr.	Residential

General: The structure was observed from the exterior only. It was occupied and in good condition. The grade around the structure is generally level, with a downhill slope toward the eastern edge. The structure is situated on a suburban site and free standing. The structure has a wooden side porch with brick pillars. The structure has a rear wooden deck (~8'x10').

Construction: The structure is a two-story building with a full basement. The foundation is concrete block. The structure is wood framed with a combination of brick veneer and vinyl siding. There is an addition on the rear of the structure with a walk out full basement. The structure has a one-car integral garage. The structure has 10 structural corners, three pedestrian doorways, and one chimney.

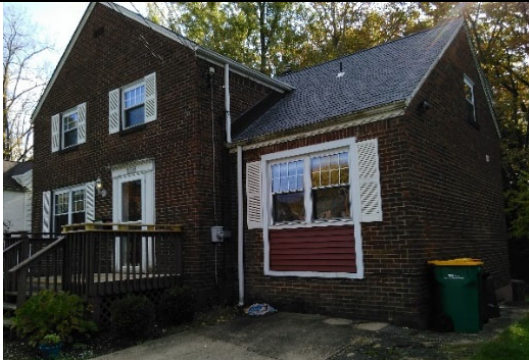
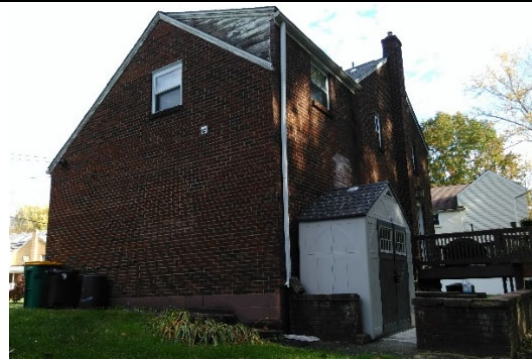
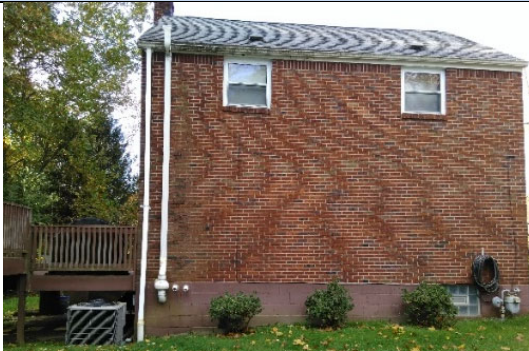
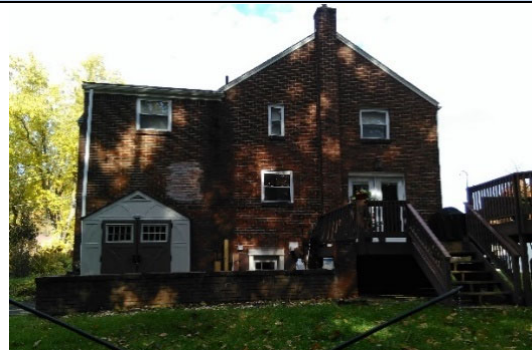
ID #	COUNTY	STREET ADDRESS	OCCUPANCY
OH-16	Allegheny	208 South Margery Dr.	Residential

General: The structure was observed from the exterior only. It was occupied and in good condition. The grade around the structure is gently sloping downhill towards the rear of the structure. The structure is situated on a suburban site and free standing.

Construction: The structure is a two-story building with a full basement. Foundation is concrete block. The structure is wood framed with brick veneer. The structure has six structural corners, three pedestrian doorways, and one chimney. The structure has a wooden front porch and rear deck (~15'x8').

Proposed Mitigation Measure	Estimated Cost
<i>Actions to reduce flood risk up to the 1% ACE flood elevation:</i>	
1. Relocate utilities to upper level or addition. Fill basement and install flood louvers in exterior walls. Elevate structure and HVAC unit 2'-0" above the 1% ACE flood elevation.	1. \$182,000

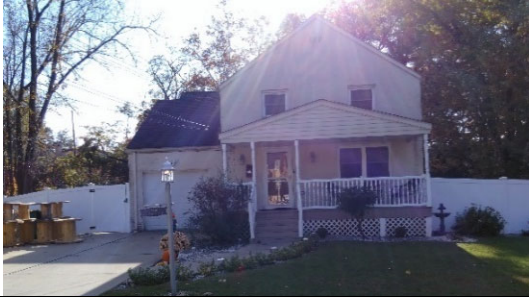
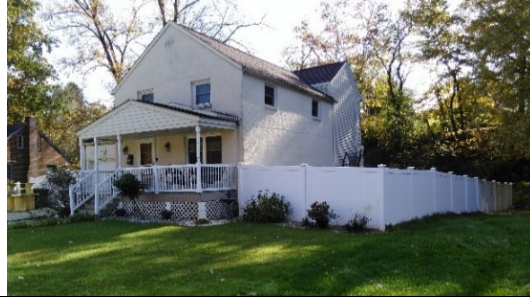
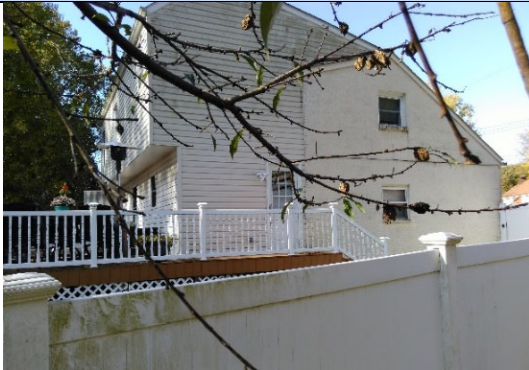
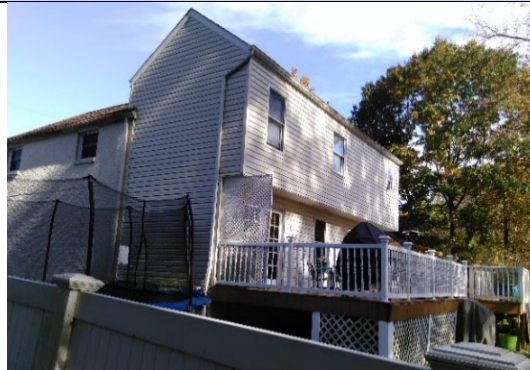
STRUCTURE DATA / ASSESSMENT SHEET			
ID #	COUNTY	STREET ADDRESS	OCCUPANCY
OH-17	Allegheny	210 South Margery Dr.	Residential

General: The structure was observed from the exterior only. It was occupied and in good condition. The grade around the structure is generally level. The structure is situated on a suburban site and free standing.

Construction: The structure is a two-story building with a main structure and a rear addition. There is a full basement beneath the main structure and addition. The foundation is concrete block. The main structure is wood framed with brick veneer. The addition is wood framed with vinyl siding. The structure has six structural corners and three pedestrian doorways. The structure has front (~5'x20') and rear (~15'x20') wooden decks. The structure has one attached garage with a slab-on-grade foundation.

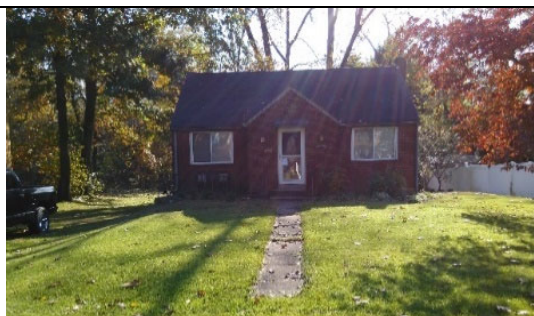
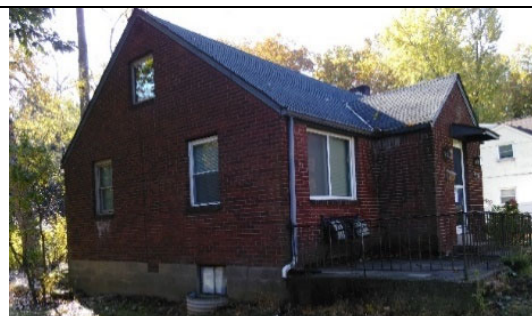
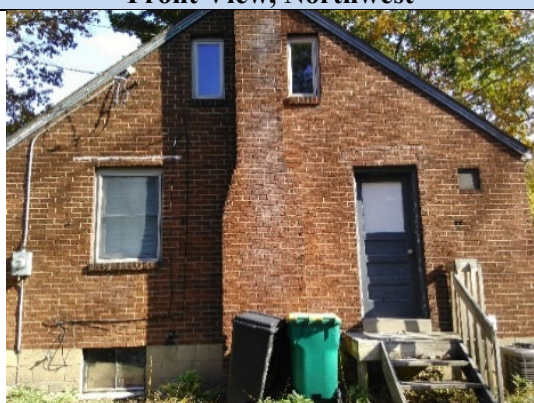
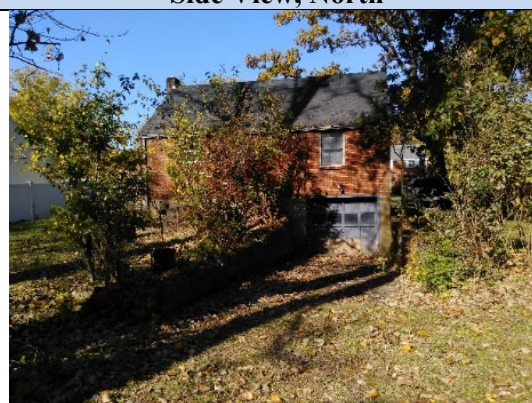
ID #	COUNTY	STREET ADDRESS	OCCUPANCY
OH-18	Allegheny	212 South Margery Dr.	Residential

General: The structure was observed from the exterior only. It was occupied and in fair condition. The grade around the structure is level with a slight downhill slope at the rear of the structure toward the rear garage. The structure is situated on a suburban site, free standing, with one integral one-car garage. The structure has a concrete slab porch at front entrance.

Construction: The structure is a two-story building with a full basement. Foundation is concrete block. The structure is wood framed with brick veneer. The structure has eight structural corners, two pedestrian doorways, and one chimney.

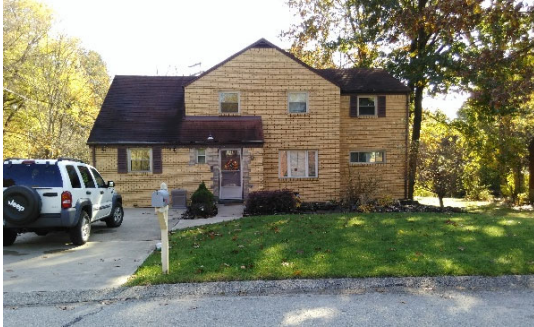
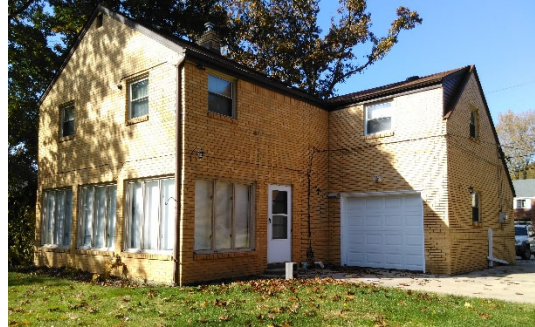
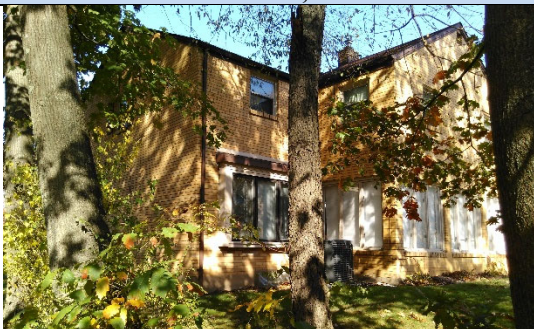
ID #	COUNTY	STREET ADDRESS	OCCUPANCY
OH-19	Allegheny	214 South Margery Dr.	Residential

General: The structure was observed from the exterior only. It was occupied and in good condition. The grade around the structure is level. The structure is situated on a suburban site and free standing with an integral one-car garage.

Construction: The structure is a two-story building with a full basement, which has had standing water. A back-flow preventer has been installed. Foundation of the main structure is concrete block. Foundation of the garage is concrete slab. The structure is wood framed with brick veneer. The structure has 14 structural corners, two pedestrian doorways, and one chimney.

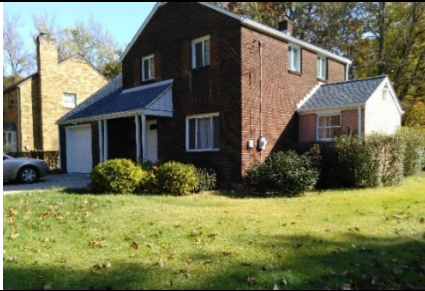
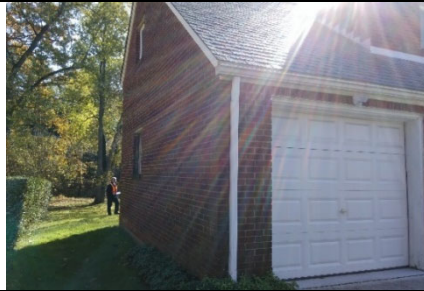
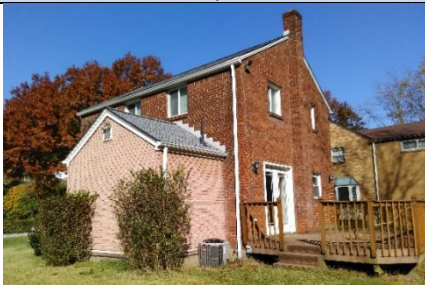
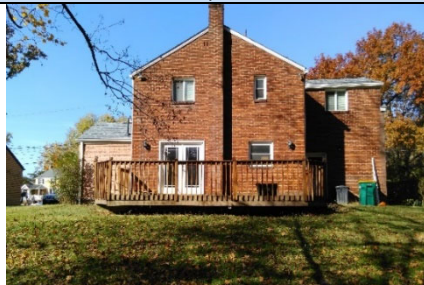
ID #	COUNTY	STREET ADDRESS	OCCUPANCY
OH-20	Allegheny	216 South Margery Dr.	Residential

General: The structure was observed from the exterior only. It was occupied and in good condition. The grade around the structure is level. The structure is situated on a suburban site and free standing with an integral one-car garage. The structure has a back deck (12’x25’).

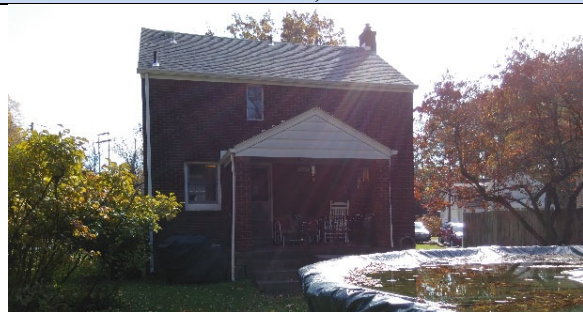
Rear View, West

General: The structure was observed from the exterior only. It was occupied and in good condition. The grade around the structure is generally level; however, the grade slopes down toward the walk out basement in front. The structure is situated on a suburban site and free standing.

Construction: The structure is a two-story building with a full basement. Foundation is concrete block. The structure is wood framed with brick veneer. The structure has eight structural corners, two pedestrian doorways, and one chimney.

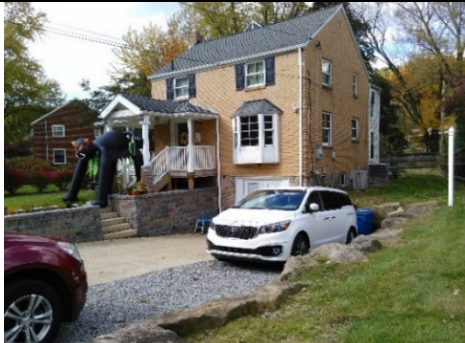
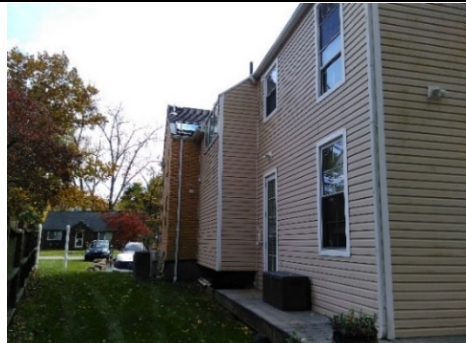
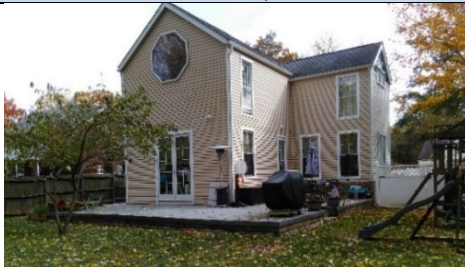
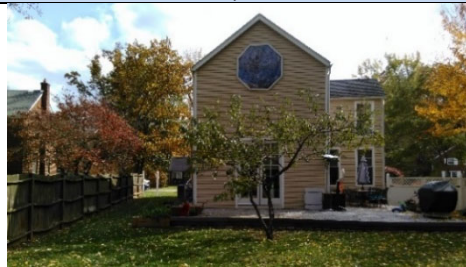
General: The structure was observed from the exterior only. It was occupied and in good condition. The grade around the structure is generally level; however, the grade slopes down toward the walk out basement in the front. The structure is situated on a suburban site and is free standing. The structure has a wooden wrap-around porch in the front and a concrete wrap-around patio in the rear.

Construction: The structure is a two-story building. The original structure has a full walk-out, finished basement with a concrete block foundation and is wood framed with brick veneer. There is an addition in the rear. A portion of the addition has a full basement. With the remainder having a crawl space. The addition is wood framed with vinyl siding. The structure has 10 structural corners, six pedestrian doorways, and one chimney.

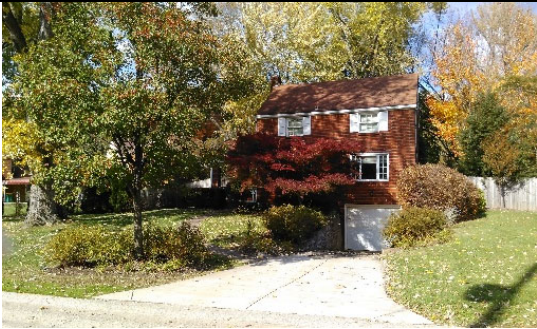
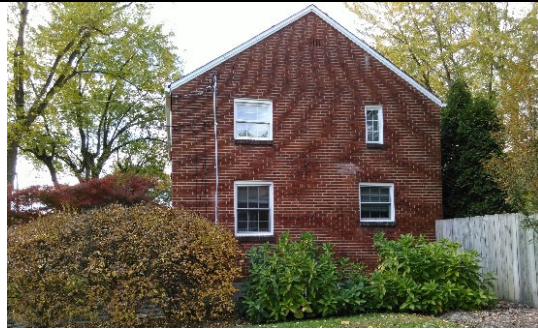
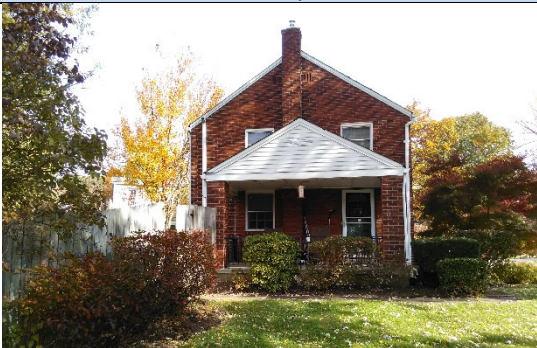
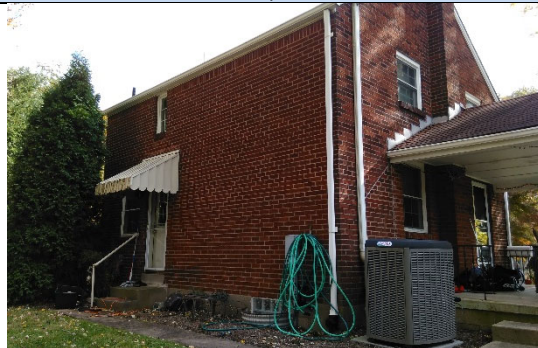
General: The structure was observed from the exterior only. It was occupied and in good condition. The structure is situated on a suburban site and free standing with a one-car integral garage. The structure has a concrete side porch with brick pillars. The grade around the structure is generally level; however, the grade slopes down toward the integral garage in front.

Construction: The structure is a two-story building with a full basement. Foundation is concrete block. The structure is wood framed with brick veneer. The structure has six structural corners, two pedestrian doorways, and one chimney.

Proposed Mitigation Measure	Estimated Cost
<i>Actions to reduce flood risk up to the 1% ACE flood elevation:</i>	
1. Relocate utilities to upper level. Fill basement and grade leading down to garage. Install flood louvers in exterior walls. Elevate structure and HVAC unit 2'-0" above 1% ACE flood elevation.	1. \$200,000

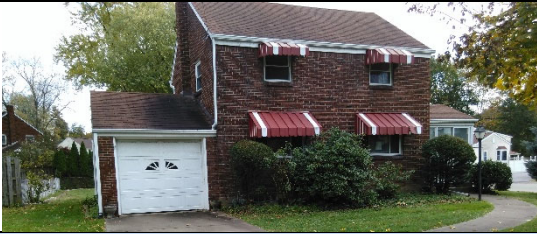
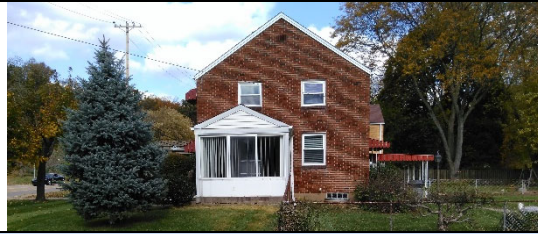
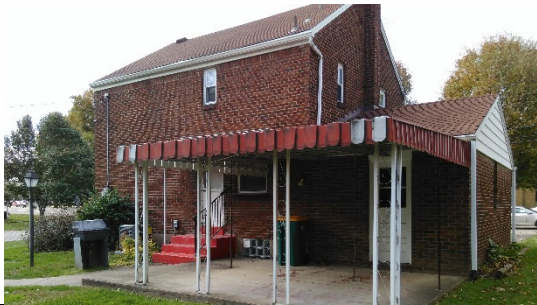
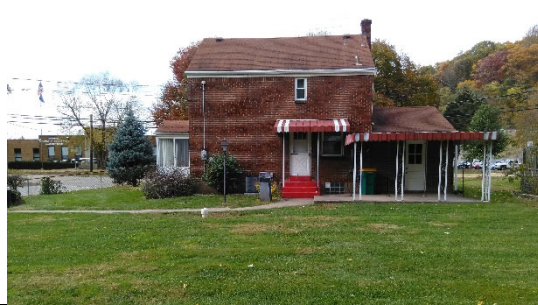
General: The structure was observed from the exterior only. It was occupied and in good condition. The grade around the structure is level. The structure is situated on a suburban site, free standing, with an attached one-car garage. The structure has a concrete slab side porch with a metal awning.

Construction: The structure is a two-story building with a full basement. The foundation of the main structure is concrete block. The foundation of the attached garage is concrete slab. The structure is wood framed with brick veneer. The structure has eight structural corners, three pedestrian doorways, and one chimney.

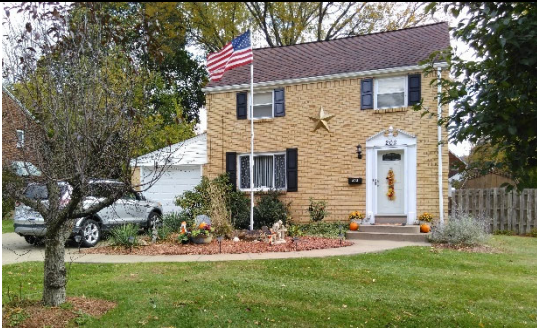
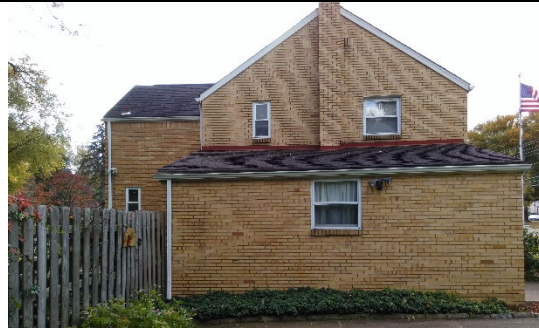
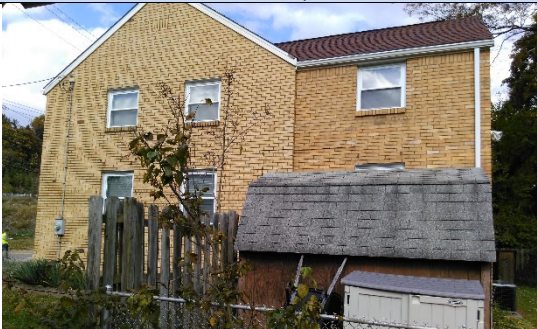
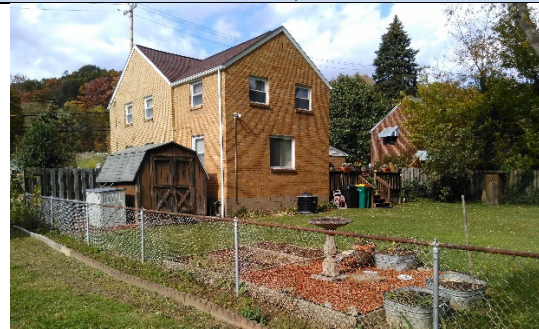
General: The structure was observed from the exterior only. It was occupied and in good condition. The grade around the structure is level. The structure is situated on a suburban site and free standing with an integral one-car garage. The structure has a concrete and gravel deck in the front of the building. There is a wooden deck in rear of structure (~12'x8').

Construction: The structure is a two-story building with a full basement. Foundation is concrete block. The structure is wood framed with brick veneer. The structure has eight structural corners, two pedestrian doorways, and one chimney.

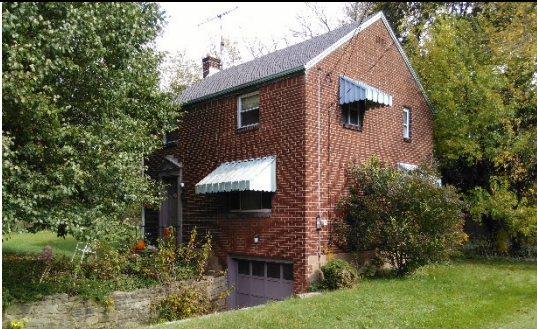
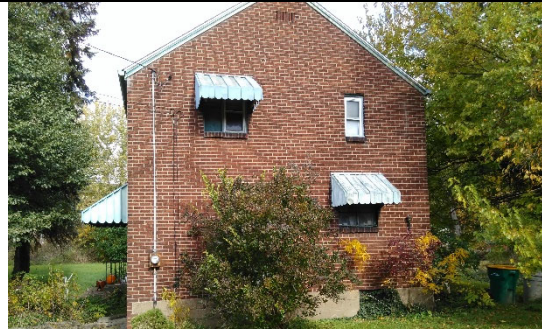
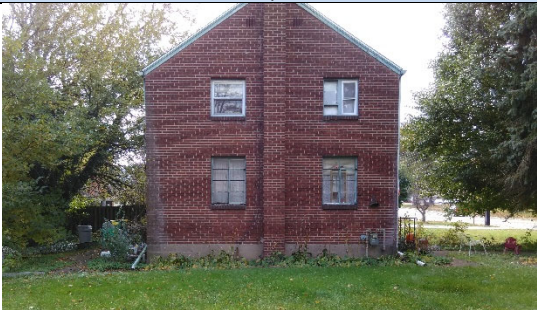
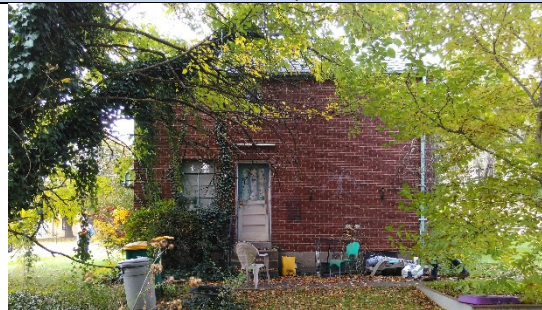
General: The structure was observed from the exterior only. It was occupied and in good condition. The structure is situated on a suburban site and free standing with a 1-car integral garage. The grade around the structure is level; however, the driveway slopes down to the garage, which is below grade.

Construction: The structure is a two-story building with a full basement. Foundation is concrete block. The structure is wood framed with brick veneer. The structure has four structural corners, two pedestrian doorways, and one chimney.

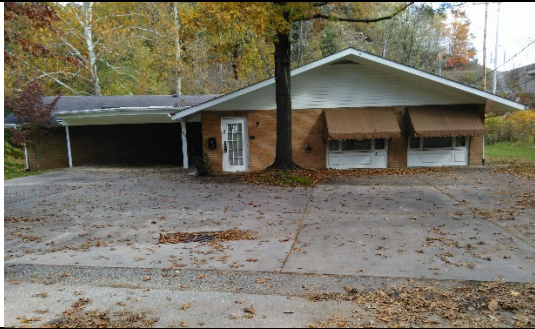
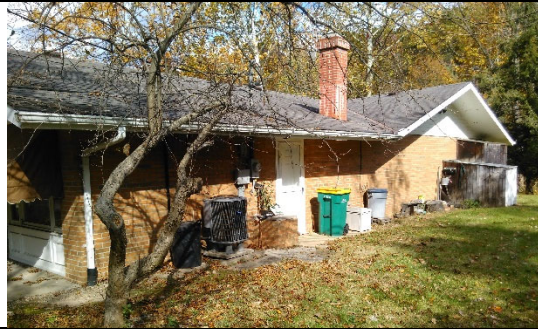
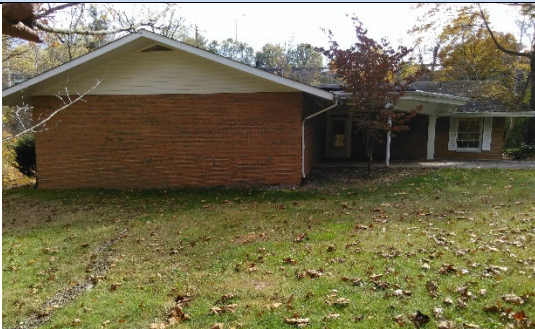
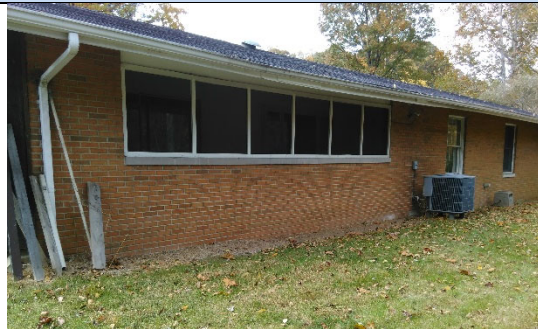
General: The structure was observed from the exterior only. It was occupied and in fair condition. The grade around the structure is level. The structure is situated on a suburban site and free standing.

Construction: The structure is a one-story building. Foundation is concrete slab and the structure is wood framed with brick veneer. The structure has six structural corners, three pedestrian doorways, and one chimney.

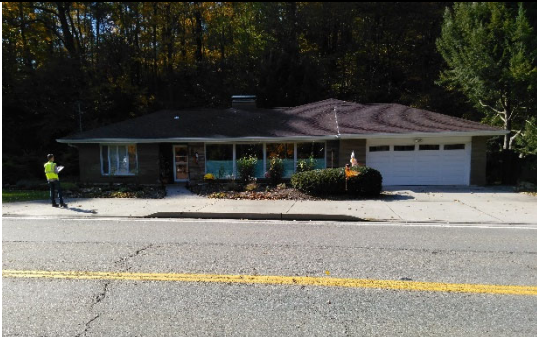
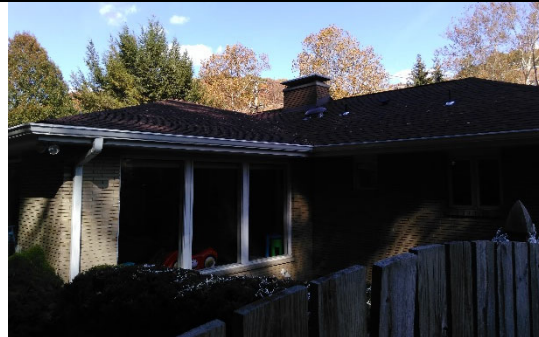
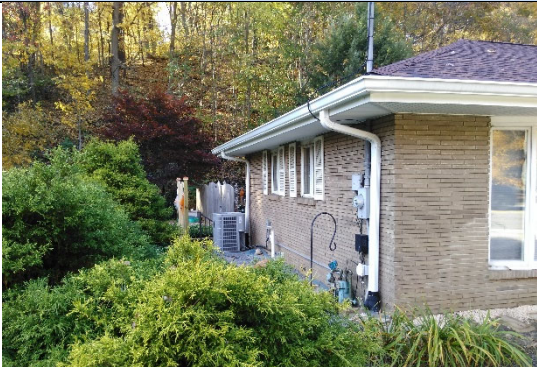
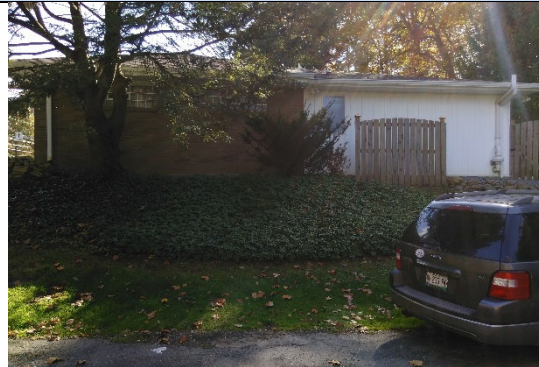
General: The structure was observed from the exterior only. It was occupied and in good condition. The grade around the structure is level. The structure is situated on a suburban site and free standing with a one-car attached garage.

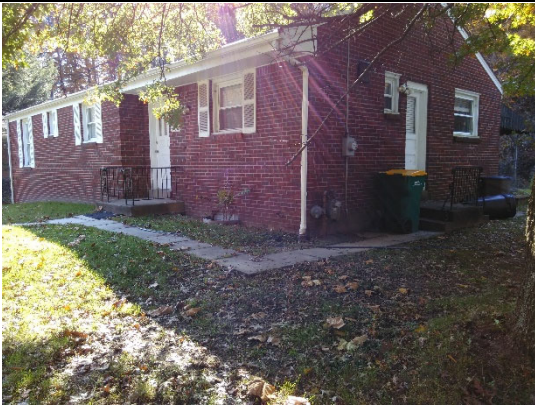
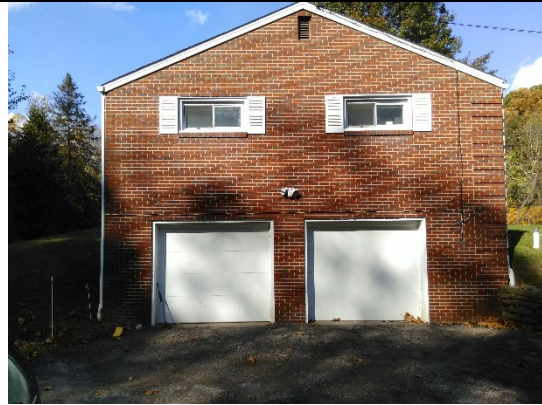
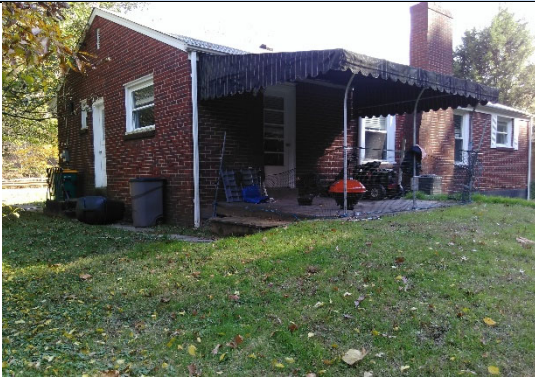
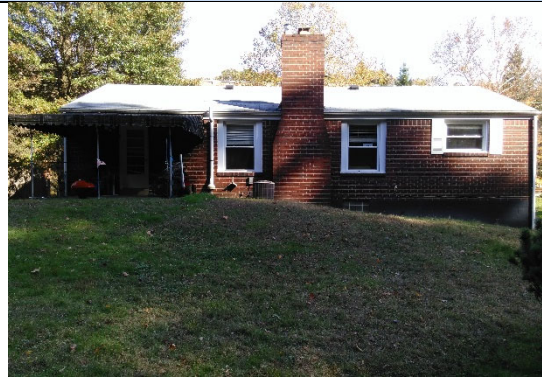
General: The structure was observed from the exterior only. It was occupied and in good condition. The structure is situated on a rural site and free standing with a two-car integral garage. The grade slopes downward towards the south side of structure toward the garage.

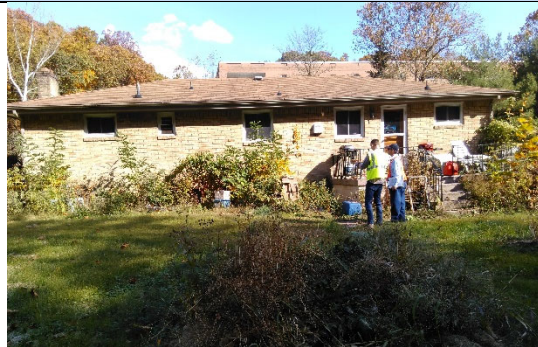
Rear View, West

General: The structure was observed from the exterior only. It was occupied and in fair condition. The grade around the structure is level. The structure is situated on a suburban site, free standing, with a one-car integral garage. There is a concrete slab porch located at the rear of the structure.

Construction: The structure is a one-story building with a full basement. Foundation of garage is concrete slab on grade. The structure is wood framed with brick veneer. The structure has 10 structural corners (6 for house and 4 for back porch). The structure has three pedestrian doorways and one chimney.

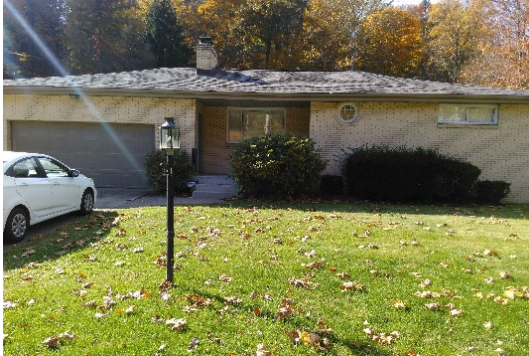
Front View, East

General: The structure was observed from the exterior only. It was occupied and in good condition. The grade around the structure is level. It is situated on a suburban site, free standing, with an integral two-car garage.

Construction: The main structure is a one-story building with a full basement. The foundation is concrete block. The structure is wood framed with brick veneer. The structure has eight structural corners, four pedestrian doorways, and one chimney.

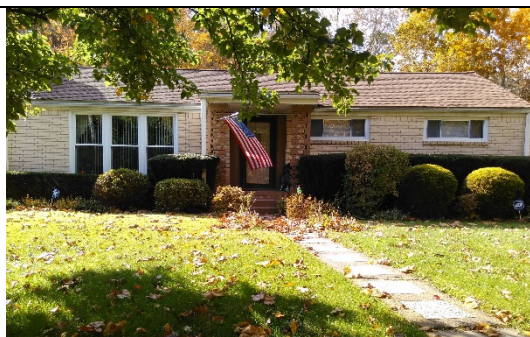
Front View, East

General: The structure was observed from the exterior only. It was occupied and in good condition. The structure is situated on a suburban site and free standing with an integral two-car garage. The structure has an enclosed rear porch. The grade slopes downward to the garages on the north side of the structure.

Construction: The main structure is a one-story building with a full basement. There is a crawl space below the rear porch. The structure is wood framed with brick veneer. The foundation of the main structure and back porch is concrete block. The structure has 10 structural corners, two pedestrian doorways, and one chimney.

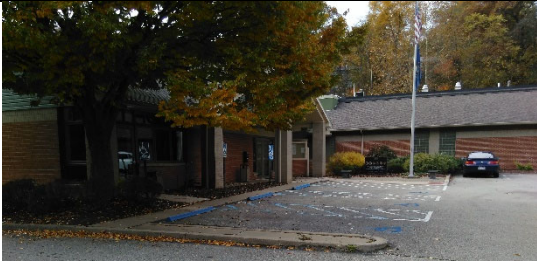
Front View, Northeast

General: This structure is the municipal building and represents a critical facility. The structure was observed from the exterior only. It was occupied and in good condition. The grade around the structure is level. The structure is situated on a suburban site, free standing, with a large garage in the rear.

Construction: The structure is a one-story building. Foundation is concrete slab and reinforced concrete slab. The structure has 8 pedestrian doorways and two garage doors.

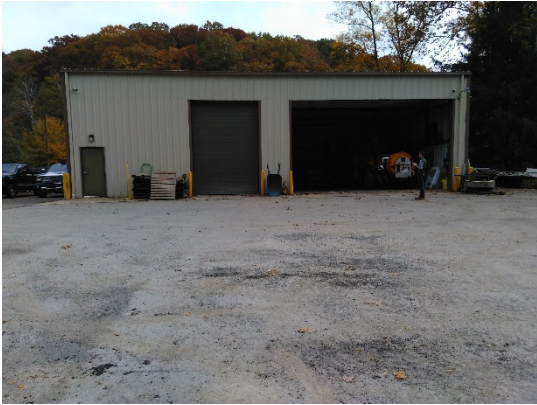
Front View, West

General: The structure was observed from the exterior only. It was occupied and in good condition. The grade around the structure is level. The structure is situated on a suburban site, is free standing, and is part of the O'Hara Municipal Building complex.

Construction: The structure is a municipal garage with two garage doors, including one single garage door and one double garage door. Foundation is concrete slab. The structure is a pre-engineered metal building with metal siding. The structure has one pedestrian doorway.

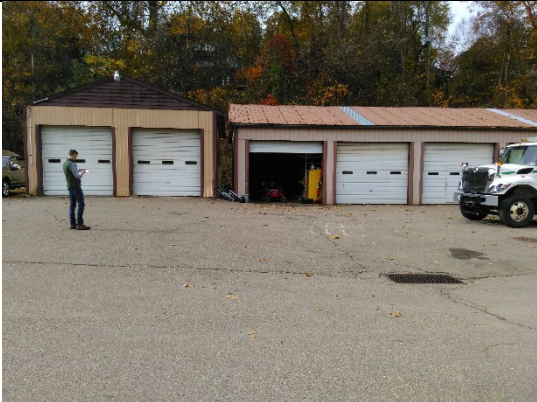
Front View, East

General: The structure was observed from the exterior only. It was in fair condition. The grade around the structure is level. There is an uphill facing slope directly behind the structure. The structure is situated on a suburban site, is free standing, and is part of the O'Hara Municipal Building complex.

Construction: The structure consists of two one-story garages that are situated directly adjacent to each other. The southern garage has two garage doors and one pedestrian doorway. The northern garage has five garage doors and one pedestrian doorway. Foundation is concrete slab. The structure construction is metal and concrete block with partial metal siding.

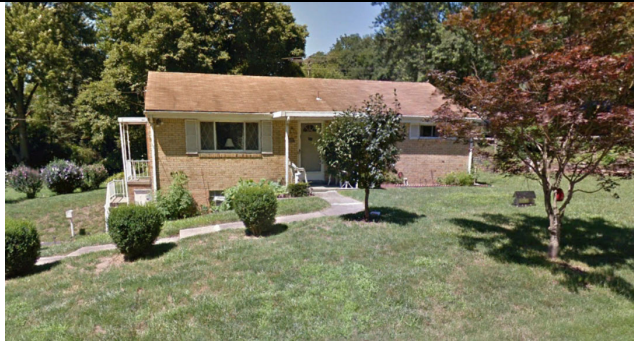
Front View, East

General: The structure was observed from Google Earth©. It is occupied and in good condition. The grade slopes down toward the garage. The structure is situated on a suburban site and is free standing.

Construction: The structure is a one-story building with a full basement and an integral garage. Foundation is concrete block. The structure is wood framed with brick veneer. The structure has four structural corners, four pedestrian doorways, and one chimney.

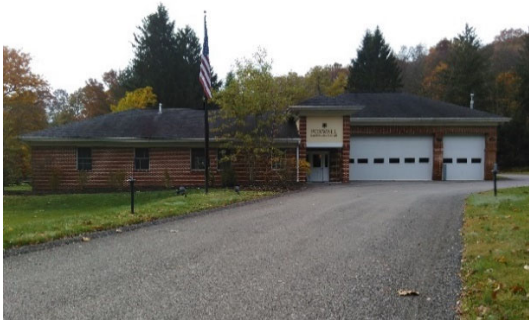
Front View, North

Construction: The structure is a one-story building. Foundation is concrete slab. The structure has three pedestrian doorways. There is a large attached garage with four garage doors for storage of emergency vehicles.
